# HJALTLAND H.A. DEEP RETROFIT PILOT PROJECT

Technical Report - PUBLIC  
November 2024

This report is a redacted version of the full Monitoring and Evaluation Report provided to Hjaltland Housing Association in June 2024. To protect tenants' privacy, all tenant feedback has been removed.

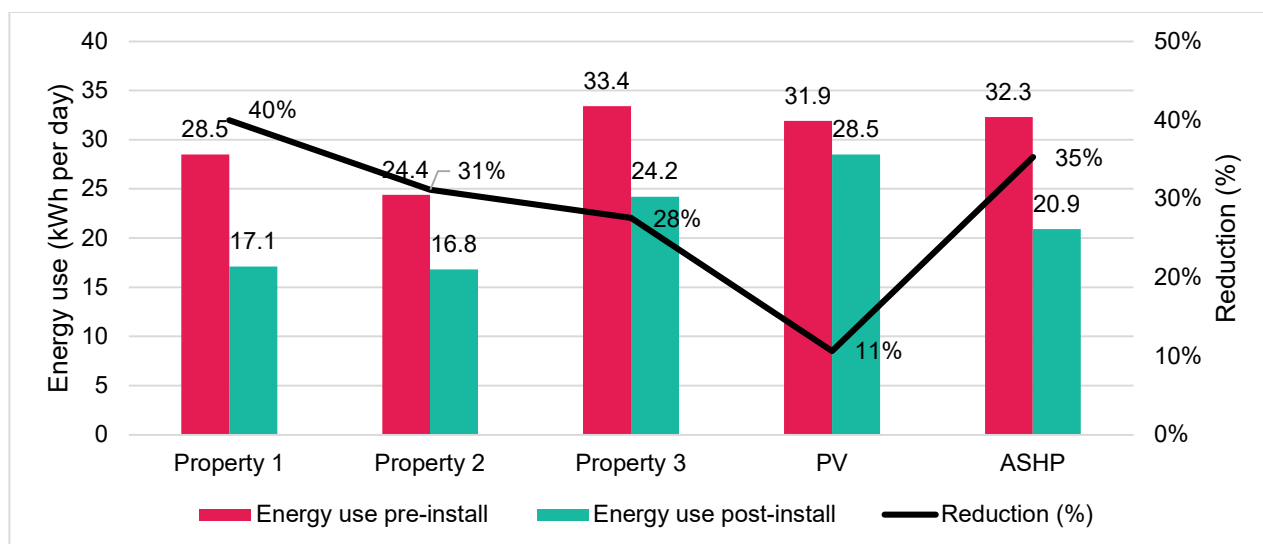
All properties saw a reduction in electricity consumption from the grid following the retrofit works (see Figure 1). The greatest energy reduction was Property 1 (40% reduction) which had fabric measures installed. All fabric first properties saw a decrease greater than the 25% energy demand reduction target.

Figure 1: Grid energy use pre- and post-install across all properties, plus percentage reduction<sup>5</sup>

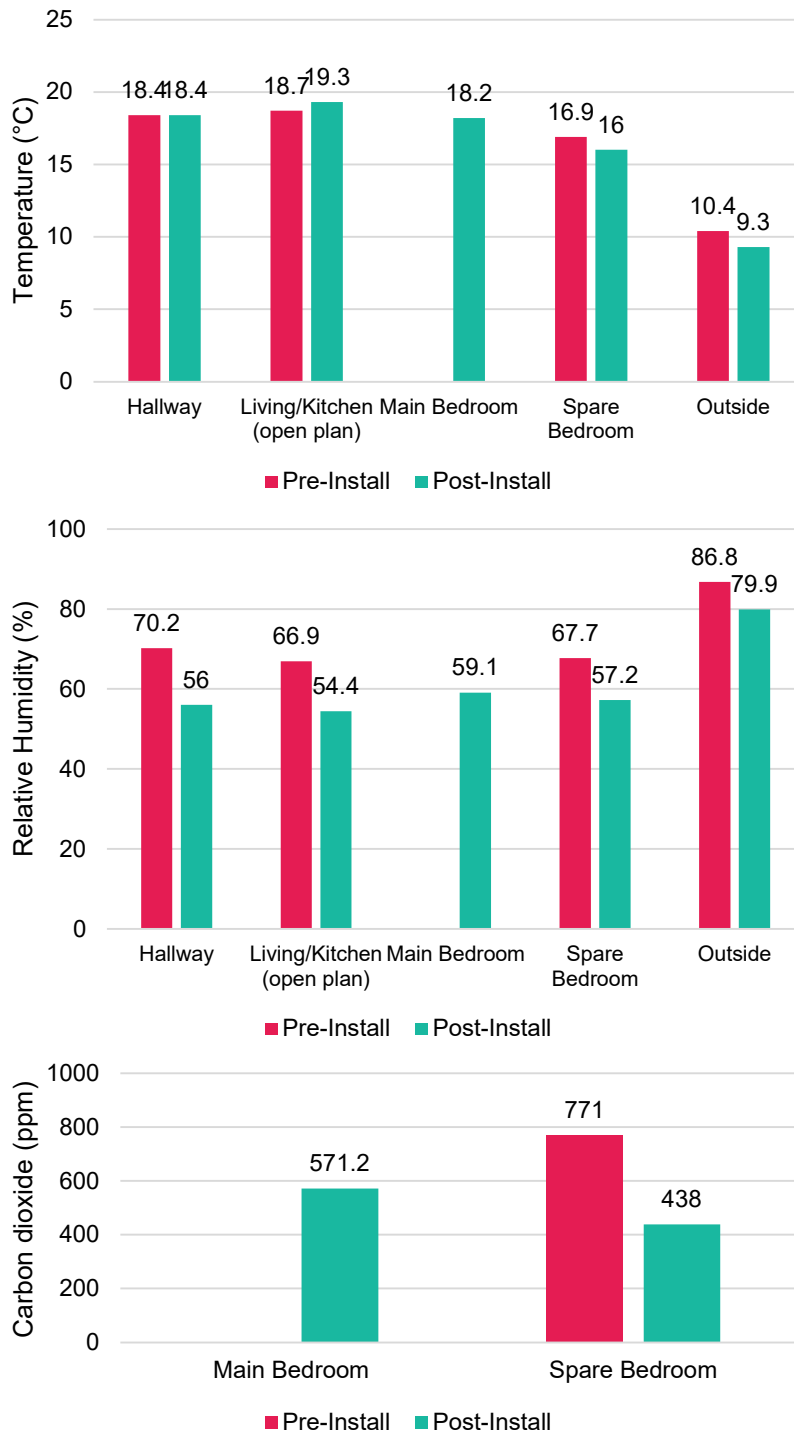
## Property 2

Figure 3: Average temperature, humidity, and carbon dioxide measurements from **Property 2**

As shown in Figure 3, the average **temperatures** within each of the rooms remained around the 18°C range throughout the 395 days following the upgrade<sup>23</sup>.

An average reduction in **humidity** levels of 18% across all monitored rooms was noted despite the fact the property is more airtight following a reduction in the passive air changes. This is due to the installation of the MVHR system which is providing the necessary air changes. All averages following the retrofit are below the 60% level where condensation might occur and significantly below the 70% level associated with mould growth. A potential damp and mould risk was flagged by the AICO monitor in the unheated spare room, however the MVHR was found to be running correctly and no condensation was reported in the property.

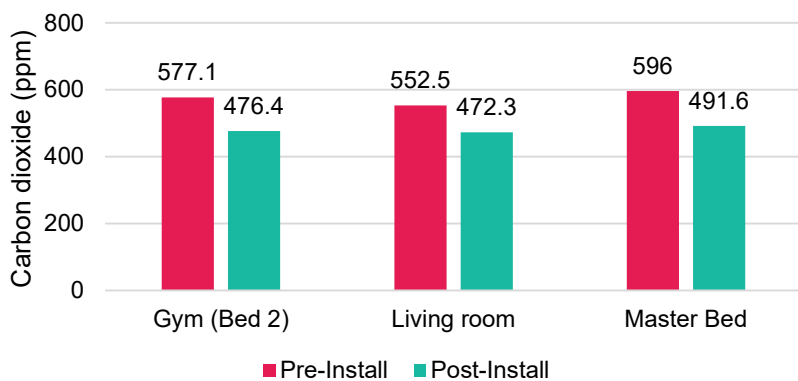
The average **temperatures**<sup>24</sup> within each of the rooms remained around 20°C throughout the heating season (October - April), as shown in Figure 4. It should be noted the average temperature prior to the upgrade was measured during the summer months, with a 4°C higher outside temperature, which may explain the drop in average temperatures from pre-installation to post-installation; however, the post-install temperatures are still within a comfortable range.

Figure 4: Average temperature, humidity, and CO<sub>2</sub> measurements from **Property 3**, pre- and post-install

An average reduction in **relative humidity** of around 11% across all rooms was noted despite the fact the property is more airtight following a reduction in the passive air changes. This is due to the installation of the MVHR system which is providing the necessary air changes. All averages following the retrofit are well below the 60% level where condensation might occur and significantly below the 70% level associated with mould growth.

<sup>24</sup> Sensors were in place for 58 days pre-install from June to August of 2022. Post-install, the sensors remained in place for 321 days from December 2022 through to October 2023. CO<sub>2</sub> was only measured in the living room, main bedroom, and gym (bedroom 2).
